DELAWARE RIVER BASIN
KAUFFMAN RUN, SCHUYLKILL COUNTY

KAUFFMAN DAM
NDS ID NO. PA-00691
DER ID NO. 54-54

PHASE I INSPECTION REPORT
NATIONAL DAM INSPECTION PROGRAM

AUGUST 1978

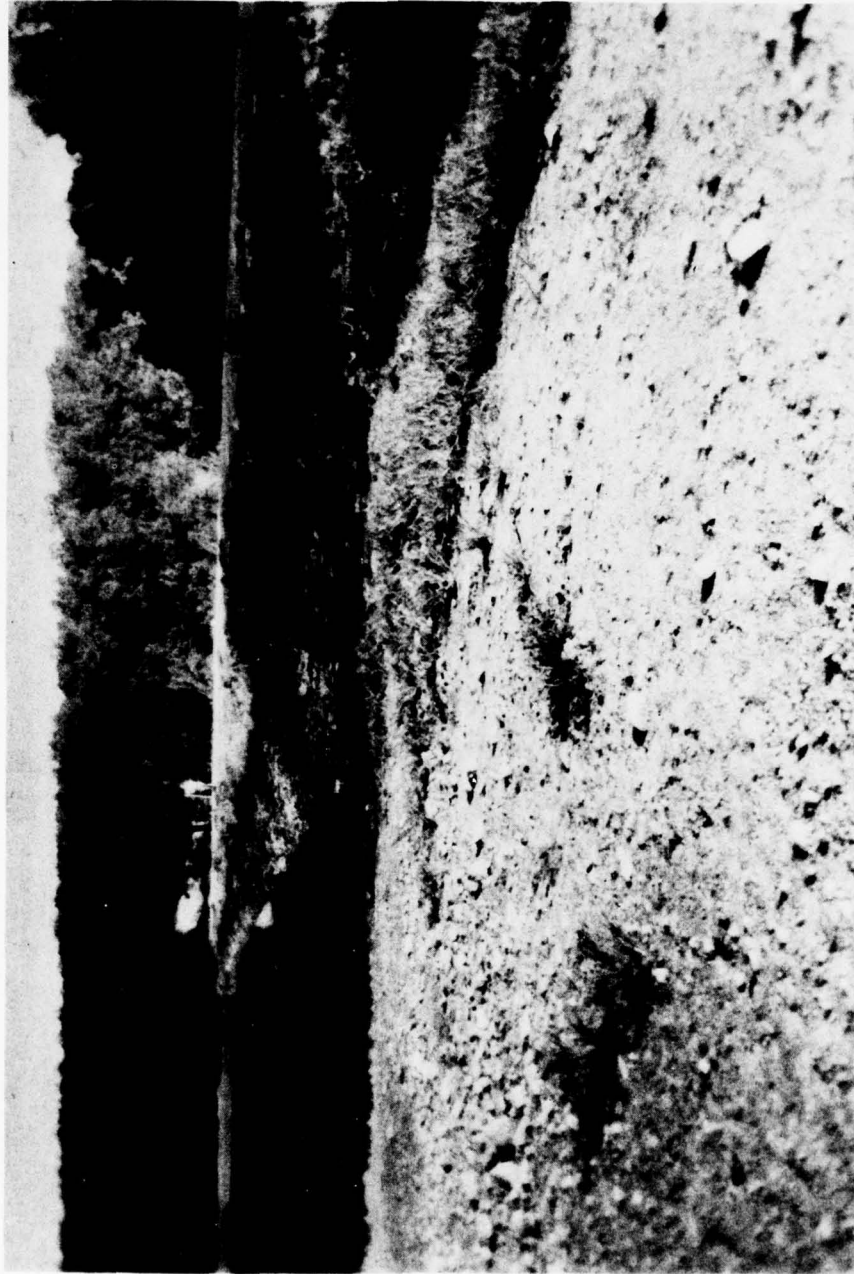
Upstream Slope of Embankment from Spillway Approach Channel.

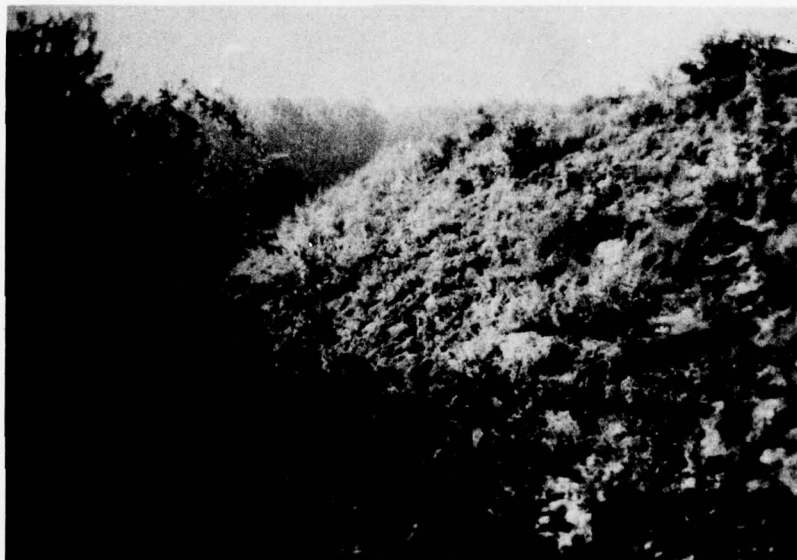
B. Downstream Slope of Embankment from Left Abutment.

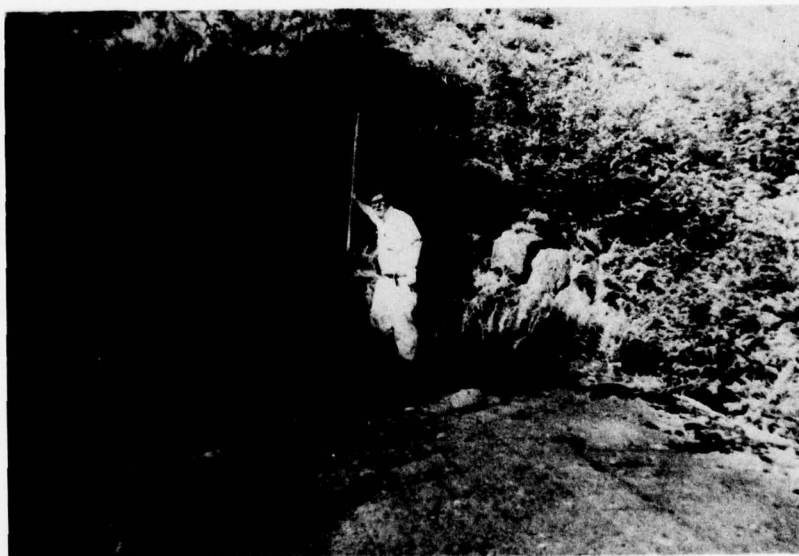
Near the highest section of the embankment, bulges were observed near the downstream toe (Photograph D). The bulges are typically 5 feet wide, 15 feet long, and they are about 1.3 feet high, measured normal to the slope.

The bulges on the downstream slope were first noted in 1924 during an inspection by the Pottsville Water Company, then the Owner. The inspection report notes that the bulges were "re-laid". The bulges were not mentioned in the next eight inspection reports. A letter, dated September 1941, from the Commonwealth to the Owner noted bulges and suggested establishing survey monuments to monitor movement. The next inspection in 1942 noted that the suggestion had not been carried out. A letter, dated September 1945, from the Commonwealth to the Owner again suggested the monitoring of the bulges. The Owner responded, in the same month, and stated that the bulges had been monitored for a year and no movement had been observed. The bulges were not noted in the 1962 and 1971 inspections by the Commonwealth. In July 1972, after Tropical Storm Agnes, the dam was inspected by the Soil Conservation Service in company with representatives of the Pennsylvania Department of Environmental Resources and the Corps of Engineers. The inspection report states that the downstream slope of the embankment was LV on LH and bulged. The inspection report recommends immediate placement of compacted rockfill on the downstream slope "for stability purposes".

seepage near the downstream toe were observed during the visual inspection. The bulges have apparently stabilized. The seepage is from a known source and flows under the embankment through a pipe. The downstream LV on 1.5H slope of the embankment is considerably steeper than current standard practice would allow. However, the concrete core wall is apparently functioning as designed, judging by the controlled seepage observed downstream of the dam. As such, it is felt that the embankment has an adequate margin of safety. Any changes in the bulges or the seepage should be cause for concern.

D. Bulge of Riprap Immediately Above Valve House.

- (5) Establish survey monuments on the embankment, especially near the bulges. Monitor the embankment at frequent intervals. If changes are noted, an evaluation of the embankment stability should be made.

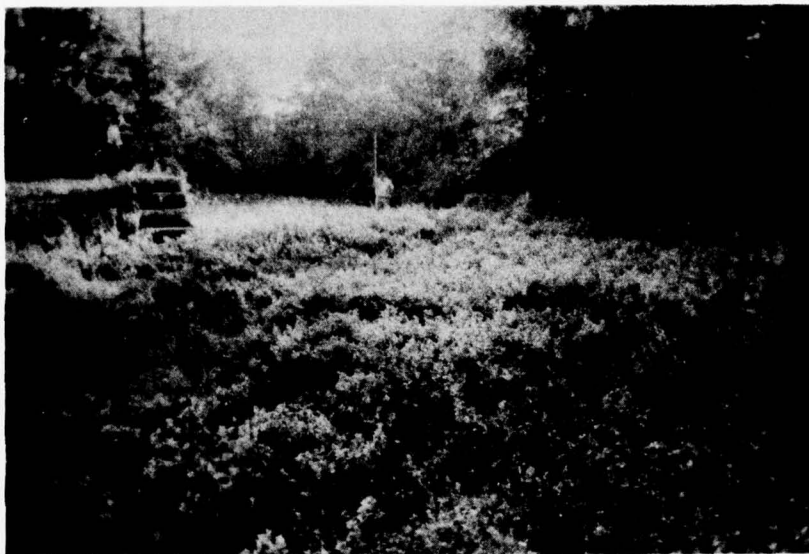
c. Appurtenant Structures. No deficiencies were observed at the spillway weir or at the masonry wall to the left of the weir. As determined by a survey performed for this inspection, the approach channel is 0.1 to 0.7 foot above spillway crest elevation. Both the approach channel and the channel downstream of the weir are generally covered with thick brush that is about 2 feet high (Photographs E and F).

E. Spillway Approach Channel —
Looking Downstream.

(2) Grade the spillway approach channel to provide adequate approach conditions.

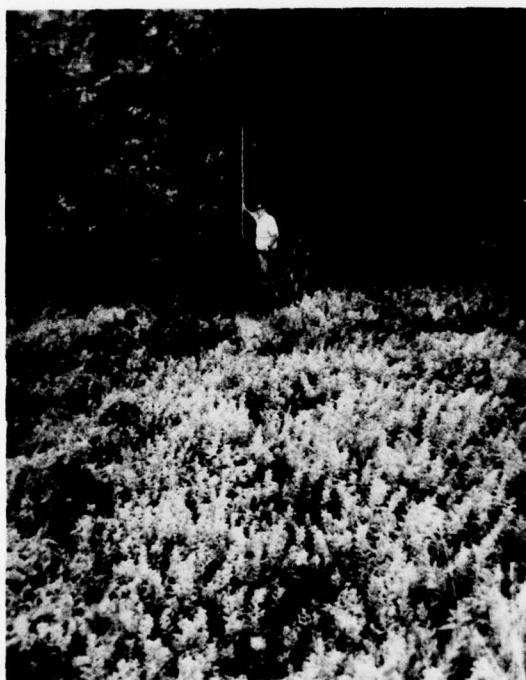
c. Visual Observations. Some visual observations relevant to hydraulics are presented in Paragraph 5.1a.(3). On the day of the inspection, brush was observed in the channels upstream and downstream of the spillway weir. This would reduce the spillway discharge capacity. A survey performed for this inspection revealed that the approach channel was from 0.1 to 0.7 foot higher than the spillway crest. Although this would have only minor effects on peak spillway discharge capacity, it would have significant effect on low head spillway discharge capacity.

F. Brush on Masonry Spillway
Weir — Flow from Right to Left.

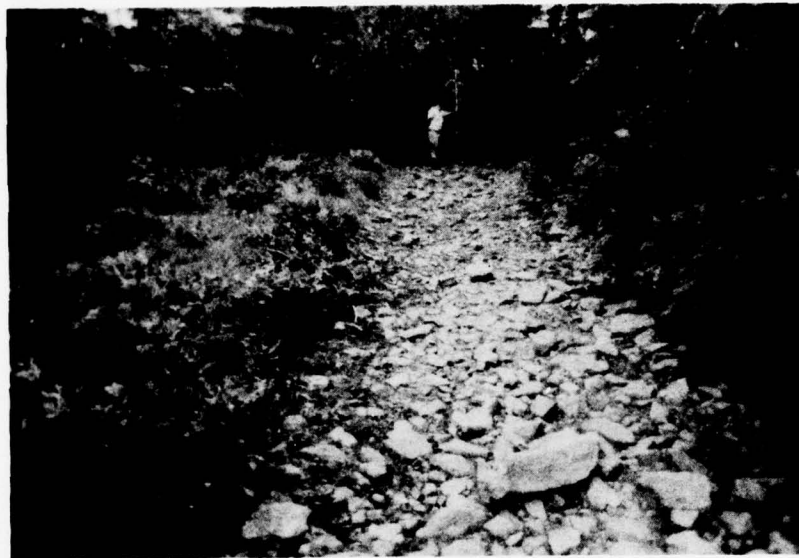
A concrete sill with a notch is located 84 feet downstream of the spillway weir (Photograph G). The channel downstream of the sill is quite narrow with heavily wooded overbanks (Photograph H). About 50 feet downstream of the sill, the channel extends down the natural hillside. The channel in this reach appears to have been eroded by the spillway flows. Beyond the toe of the hillside at the Kauffman Run overbank, the spillway channel is poorly defined. Many large piles of debris were observed (Photograph I).

G. Spillway Outlet Channel —
Looking Downstream Towards Concrete Weir.

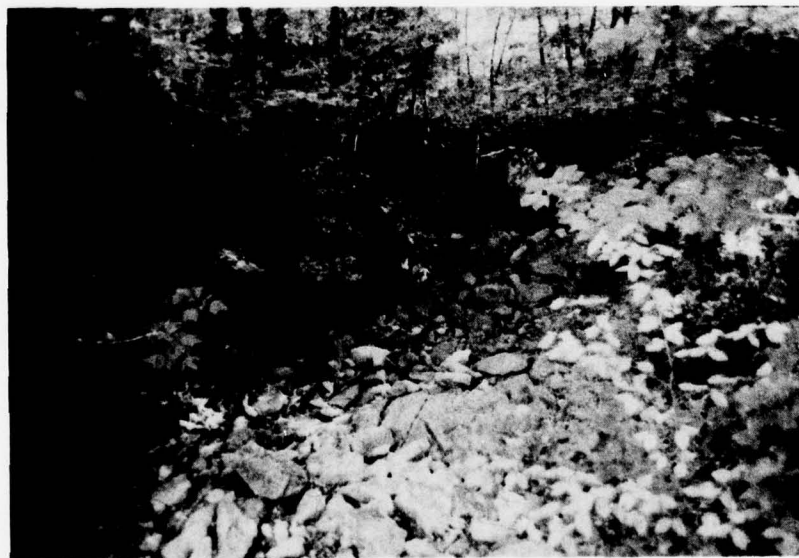
H. Spillway Outlet Channel Below Concrete Weir —
Looking Downstream.
